Problem:

Our client was experiencing excessive vibration on one of the Boiler Forced Draft Fans in their power house. We were asked to come on site to diagnose and fix the problem

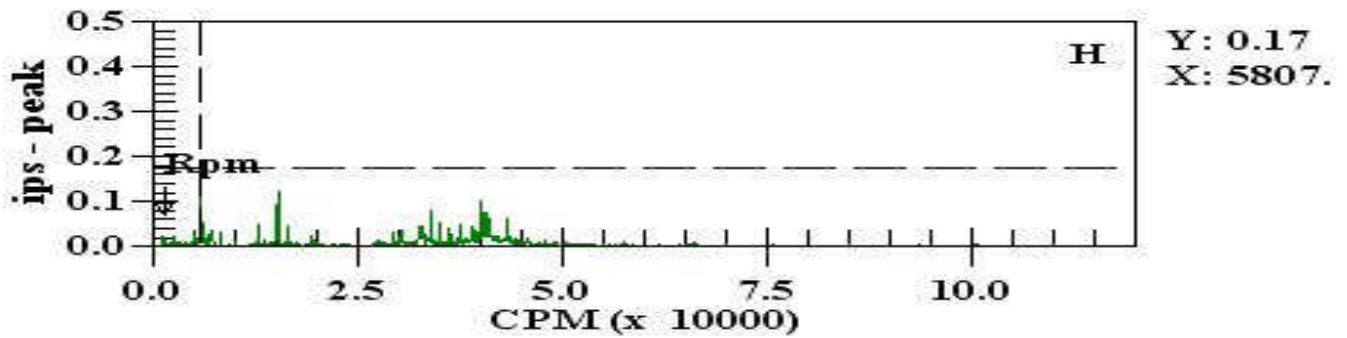
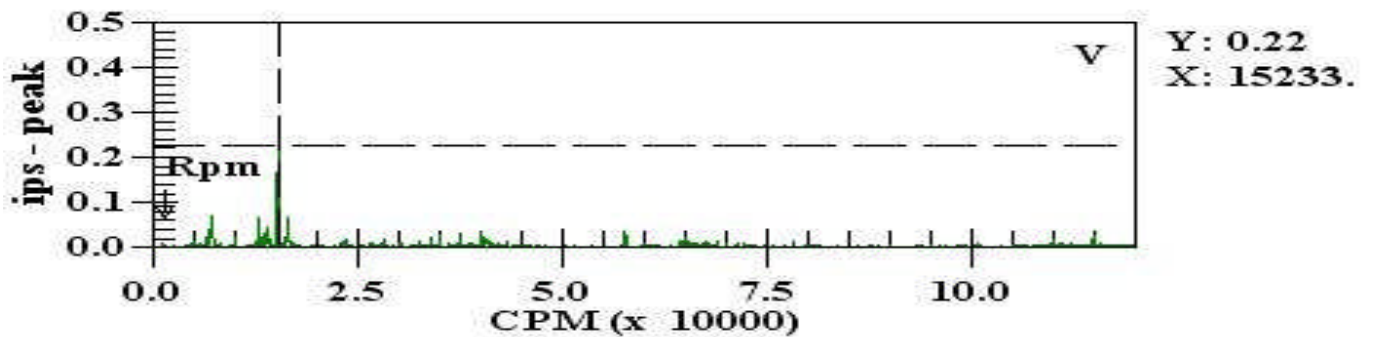
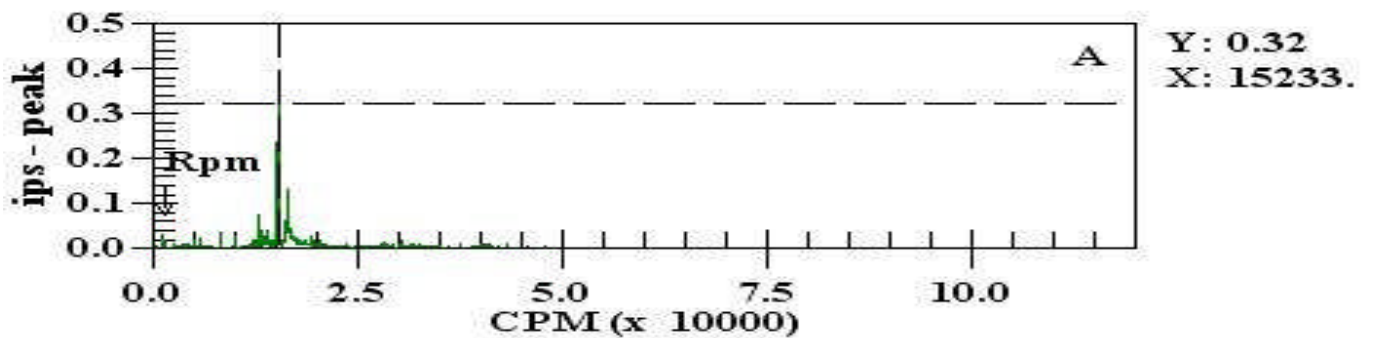
OB MOTOR

Our personnel collected vibration spectral data on all the machine bearings to identify any fault frequencies. The motor data revealed strong broadband energy in all the spectra. We also found that the highest peaks were not at whole multiples of the motor's operating speed.

The highest peak we found was at 15,233 cpm or approximately 12.69 times the motors operating speed (15,233 cpm/1200 cpm). This peak was obviously not a result of rotor bars (30x-60x rpm), motor cooling fan blade passing frequency (Nx), imbalance (1x) or even misalignment (1x/2x). The frequency was not a half-time multiple (.5x, 1.5x...8.5x rpm) of operating speed that rotor rubs or bearings loose in their housing can produce. Our technician also conducted a resonance test on the structure and found that this peak was not the result of a resonant condition. Unfortunately the customer did not have access to the bearing fault frequency information so we could not verify if the frequency matched a known bearing frequency.

However, through the process of elimination, the analyst determined that the data did not fit anything other than a bearing fault. There were signs of looseness and the dominant peak at 12.69 times the motor's operating speed was where many bearing fault frequencies are found. As a result, our personnel recommended that the client replace the motor bearings.

1. The levels were higher on the motor
2. The data suggests severe bearing wear when the data is viewed in a log format (substantial mounds of vibration energy at the foot of the bearing frequency peak)
3. The fan bearings had been more recently replaced and were more likely to be in better condition than the motor bearings.

Once the motor bearings were replaced new vibration data (As -Left) was collected. The vibration quickly revealed the analysis was correct. The odd peak frequency at 12.69 times the motor's operating speed was a bearing fault frequency. The vibration levels drastically dropped and brought the vibration well within the acceptable criterion.

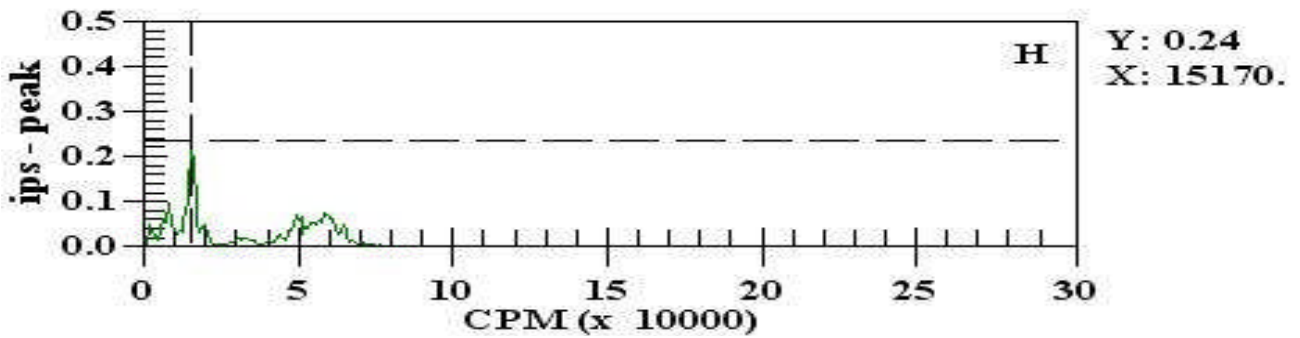
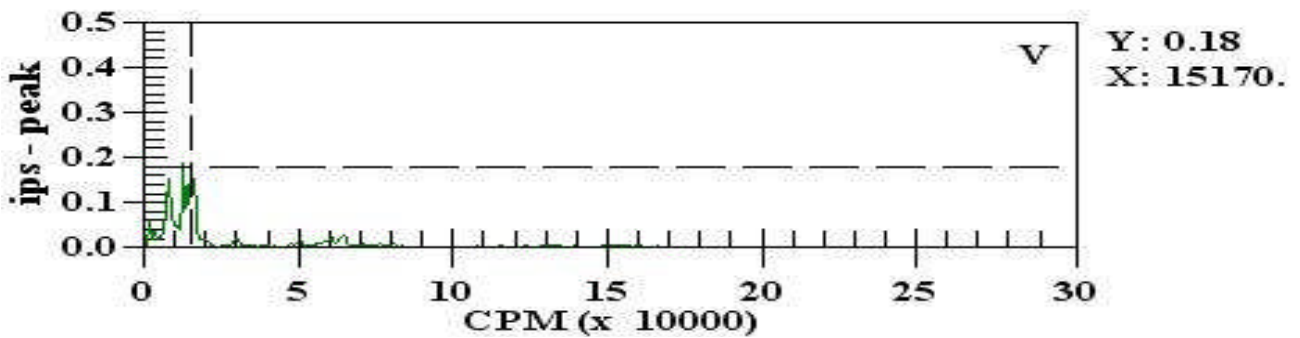
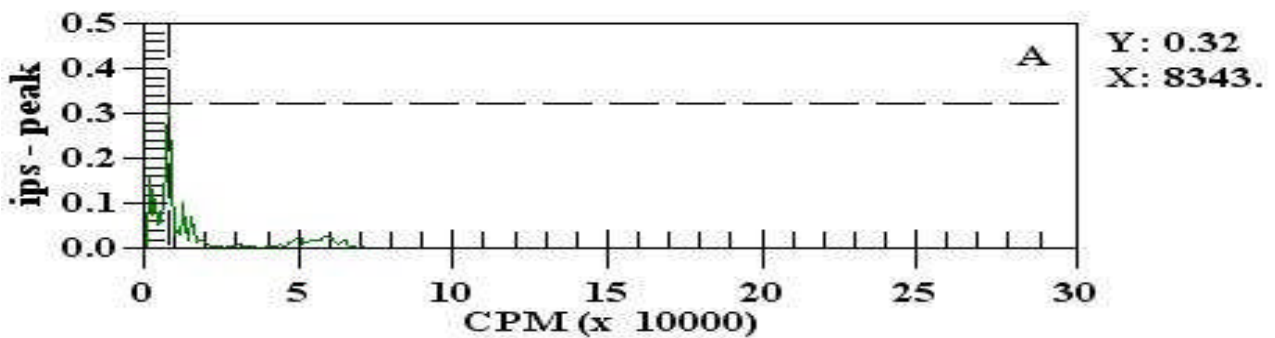
IB FAN

Even though the peak fan vibration levels (see the as-found data - axial direction) are only slightly lower than the motor peak levels the recommendation was to replace the motor bearings because:
