Problem:

Our client was experiencing excessive vibration on one of the Boiler Forced Draft Fans in their power house. We were asked to come on site to diagnose and fix the problem

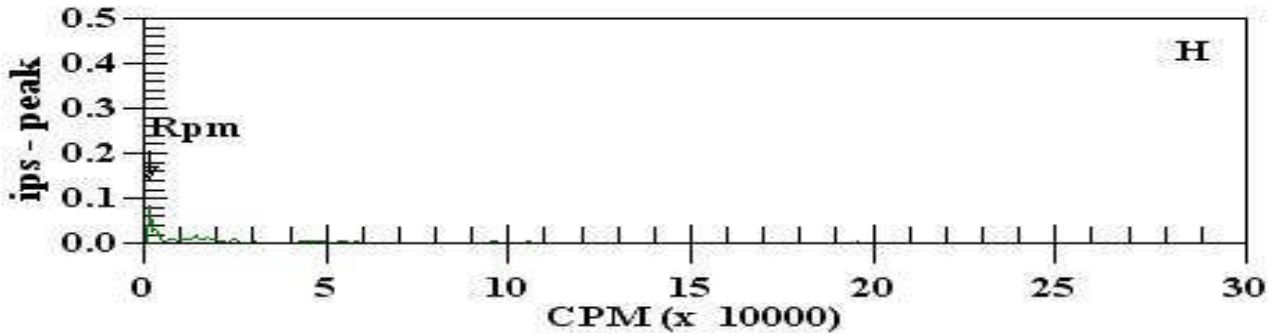
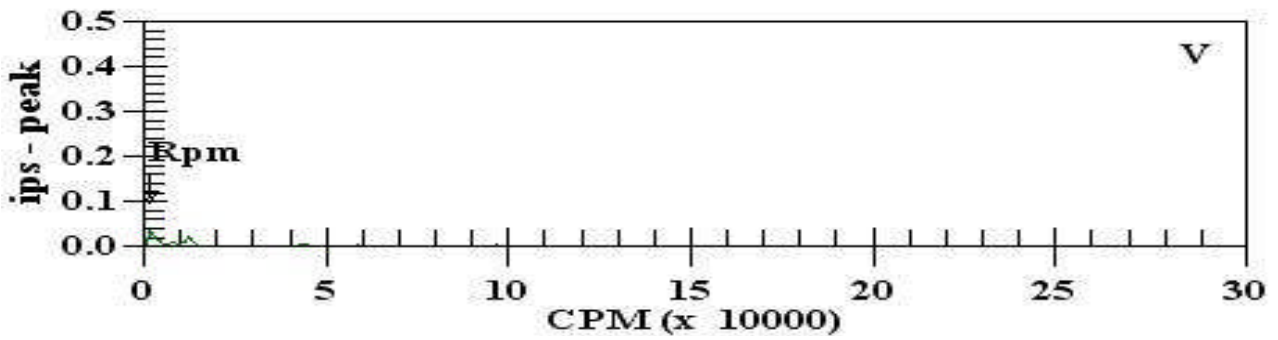
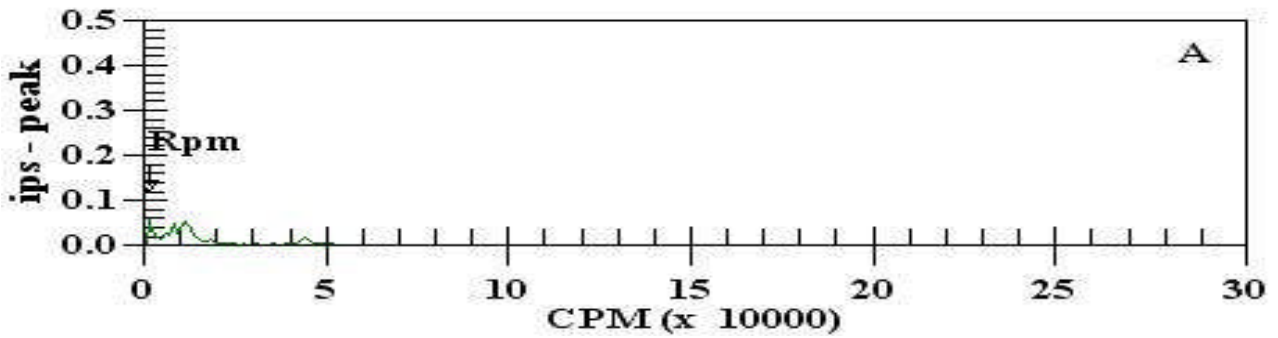
IB FAN

Once the motor bearings were replaced new vibration data (As -Left) was collected. The vibration quickly revealed the analysis was correct. The odd peak frequency at 12.69 times the motor's operating speed was a bearing fault frequency. The vibration levels drastically dropped and brought the vibration well within the acceptable criterion.

AS LEFT

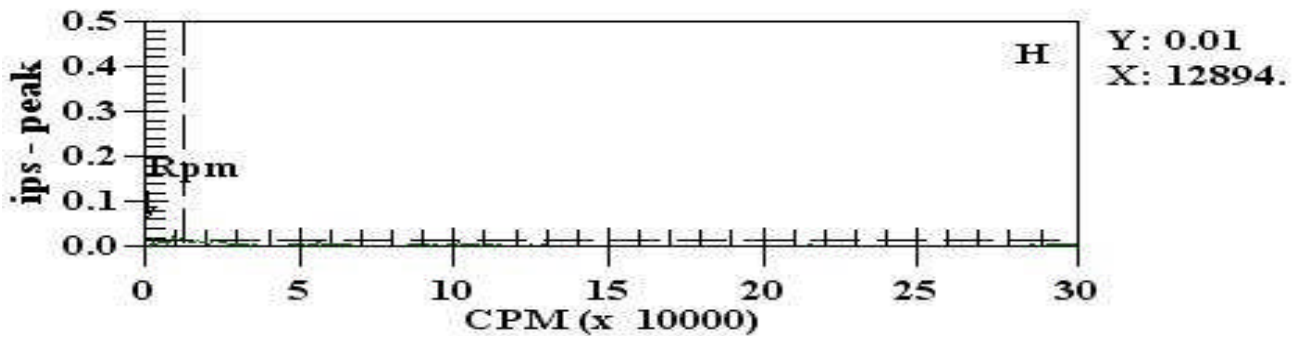
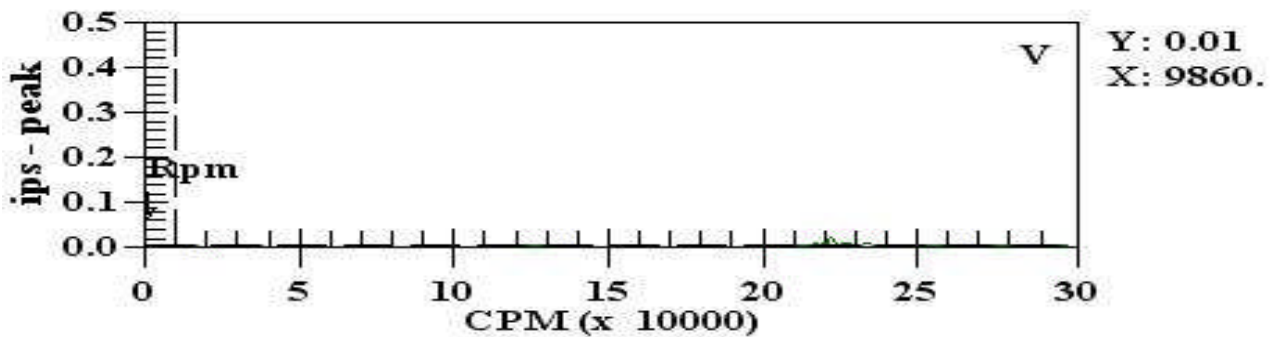
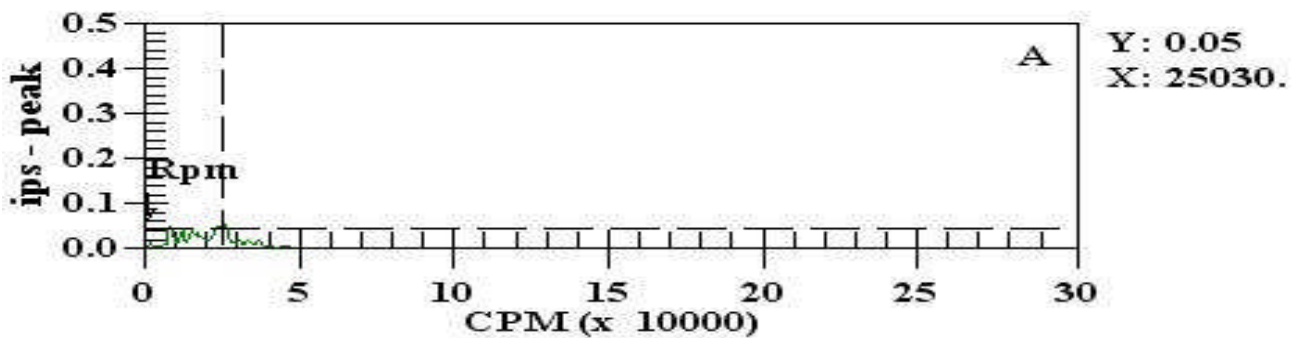
OB FAN

AS LEFT
